Rebuttal Expert Report of Konrad J. Banaszak

#### IN THE UNITED STATES DISTRICT COURT FOR THE NORTHERN DISTRICT OF ILLINOIS, WESTERN DIVISION

REBUTTAL EXPERT REPORT

KONRAD J. BANASZAK, PH.D.

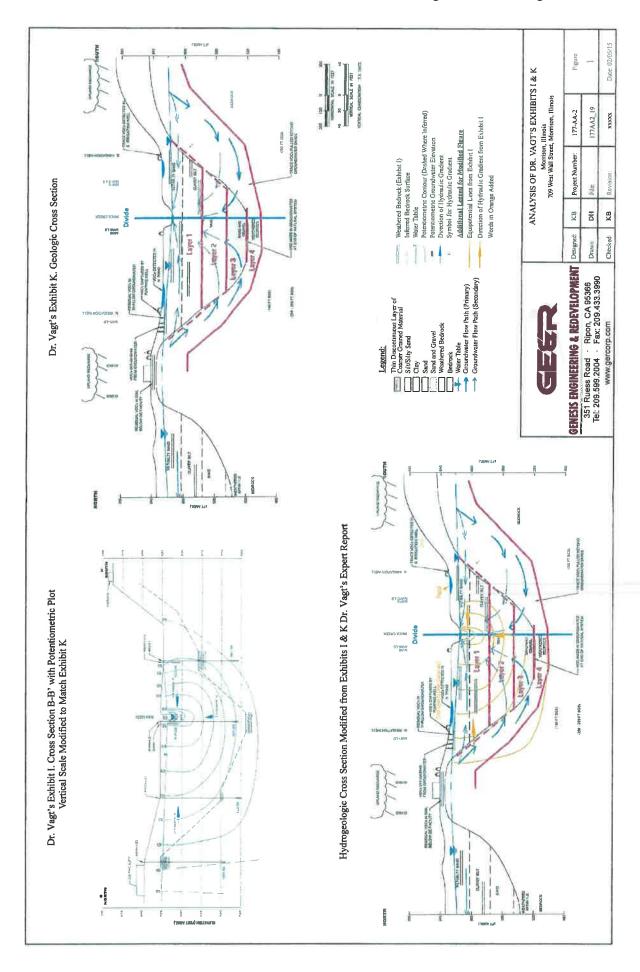
## FIGURE 1

- 3. Putting Dr. Vagt's Exhibits I and K together, the attached Figure 1, shows that Dr. Vagt has presented two different ideas with respect to groundwater flow. Exhibit I corresponds to all the mathematical analyses by Dr. Vagt, but the direction of the hydraulic gradient conflicts with the major direction of groundwater flow shown on Exhibit K. Dr. Vagt states that on his Section B-B', "Arrows have been added to show the directions of the gradients that drive groundwater flow on the north and south sides of Rock Creek and groundwater flow below the creek," (See p. 4-4, Section 4.1.2 of Dr. Vagt's Expert Report) and "it is the gradients, not the stratigraphy that drive groundwater migration (See p. 5-5 of Dr. Vagt's Expert Report, second paragraph under Part B)." Yet Dr. Vagt's own Exhibit K clearly shows stratigraphy is more important, as the main flow is down the upper bedrock zone. Flow like that shown on Exhibit K, not like that shown in Exhibit I, would allow contamination to reach the deep gravel and the broken up bedrock which is tapped by monitoring wells MW7-LS and MW8-LS, both adjacent to Rock Creek.

According to the flow postulated in Dr. Vagt's opinion based upon Exhibit I, all of the water flowing into layers 3 and 4 and the water flowing in the clay portion of layer 1 of Exhibit K must come from Dr. Vagt's layer 4 under the GE facility to the point where the top of the clay portion of layer 1 intersects the top of layer 4. These observations make the calculations (presented later in Dr. Vagt's opinion) of amounts groundwater moving in various zones to Rock Creek dubious at best.

Analysis of Dr. Vagt's Exhibits I and K
